Evaluating the Use of Drones for Timber Bridge Inspection

Junwon Seo
James P. Wacker
Luis Duque

Forest Service
Forest Products Laboratory
General Technical Report
FPL-GTR-258
August 2018

A FHWA-NHCBP (National Historic Covered Bridge Program) publication

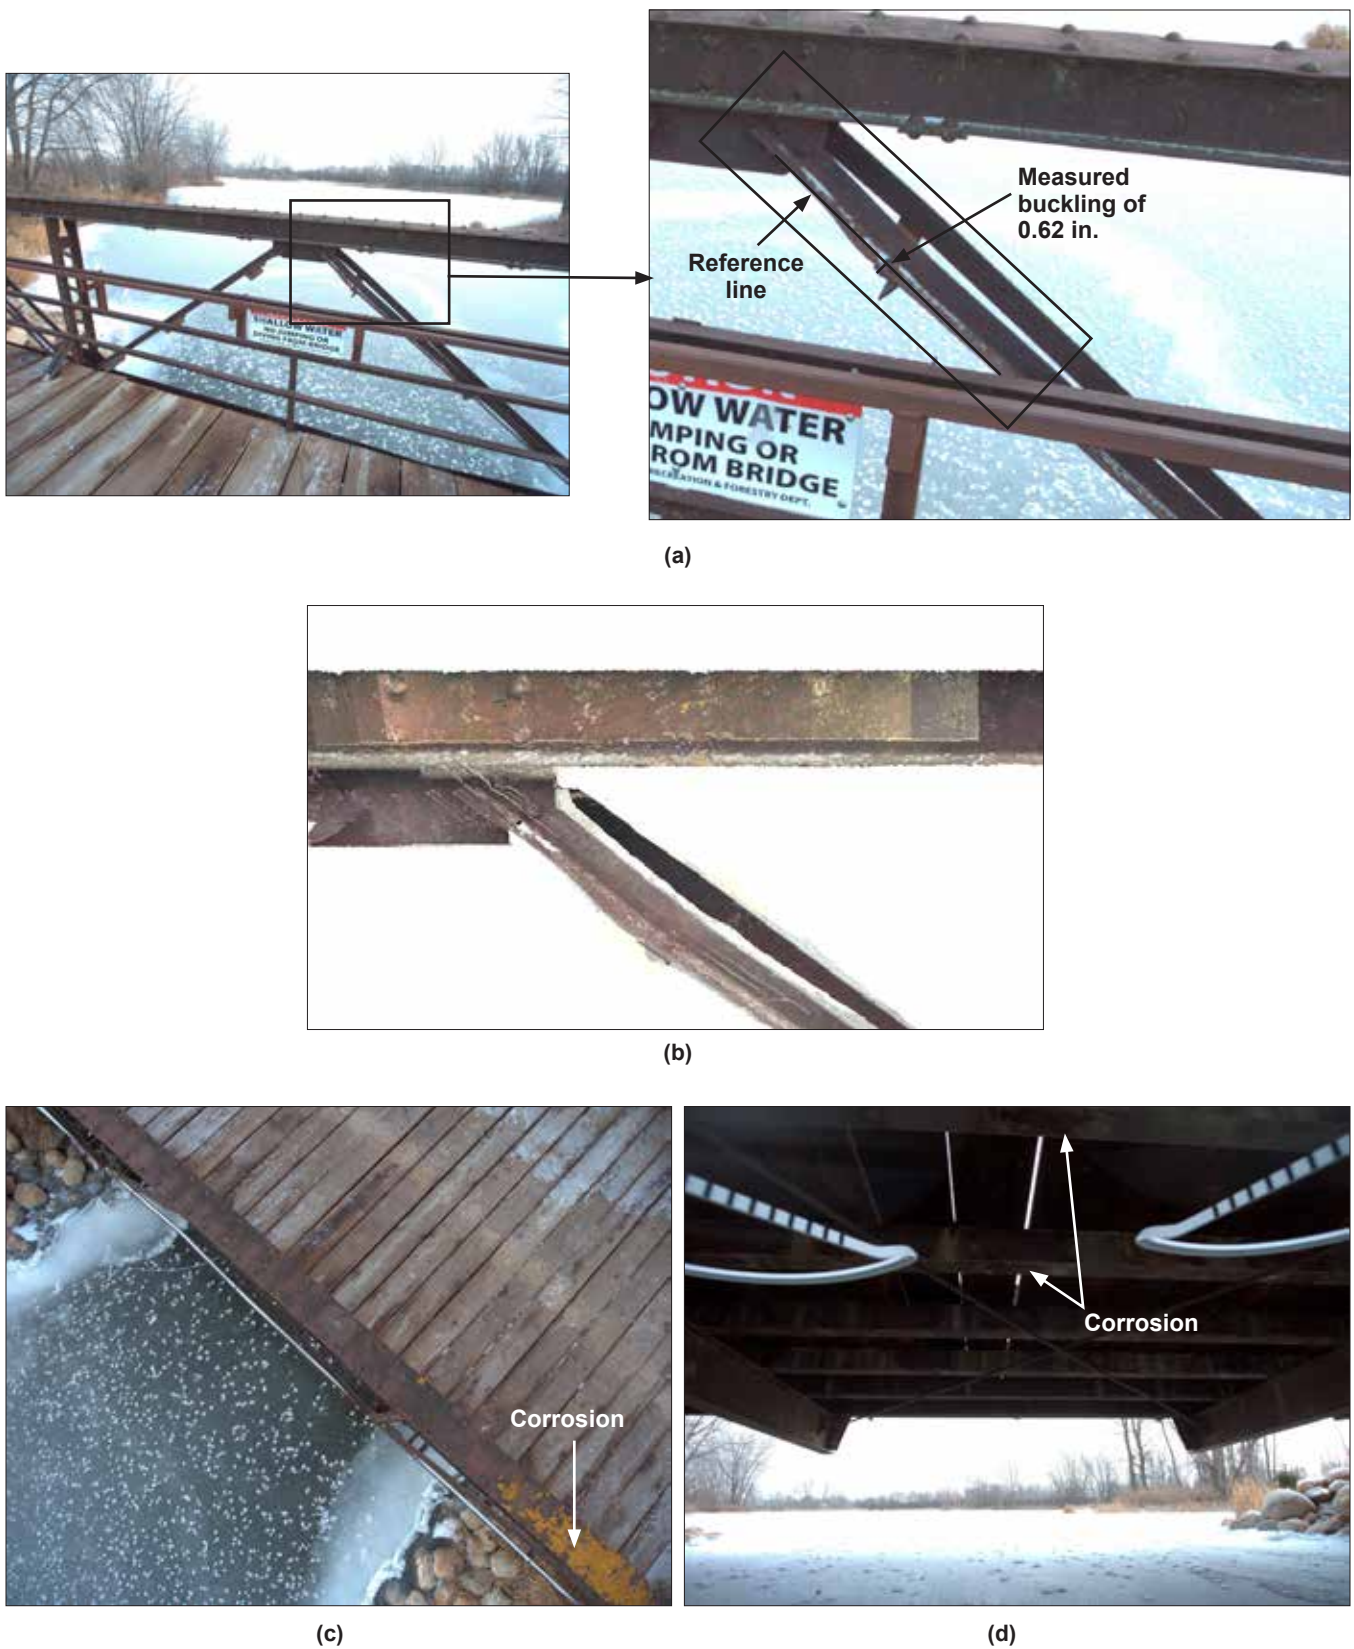
Figure 27. Damage detected using the drone during the outdoor flight: (a) steel truss member buckling; (b) steel truss member corrosion; (c) corrosion on stringers underside of bridge; (d) corrosion on stringers and cross frames.

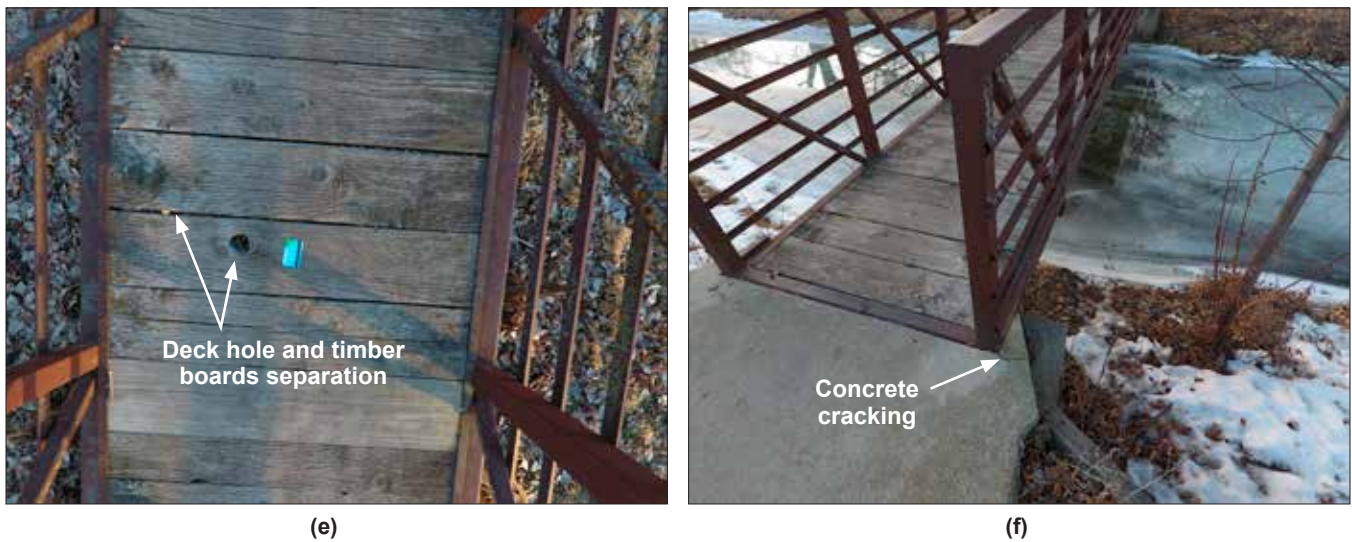
Figure 31. (e) deck hole and timber board separation; (f) abutment crack.

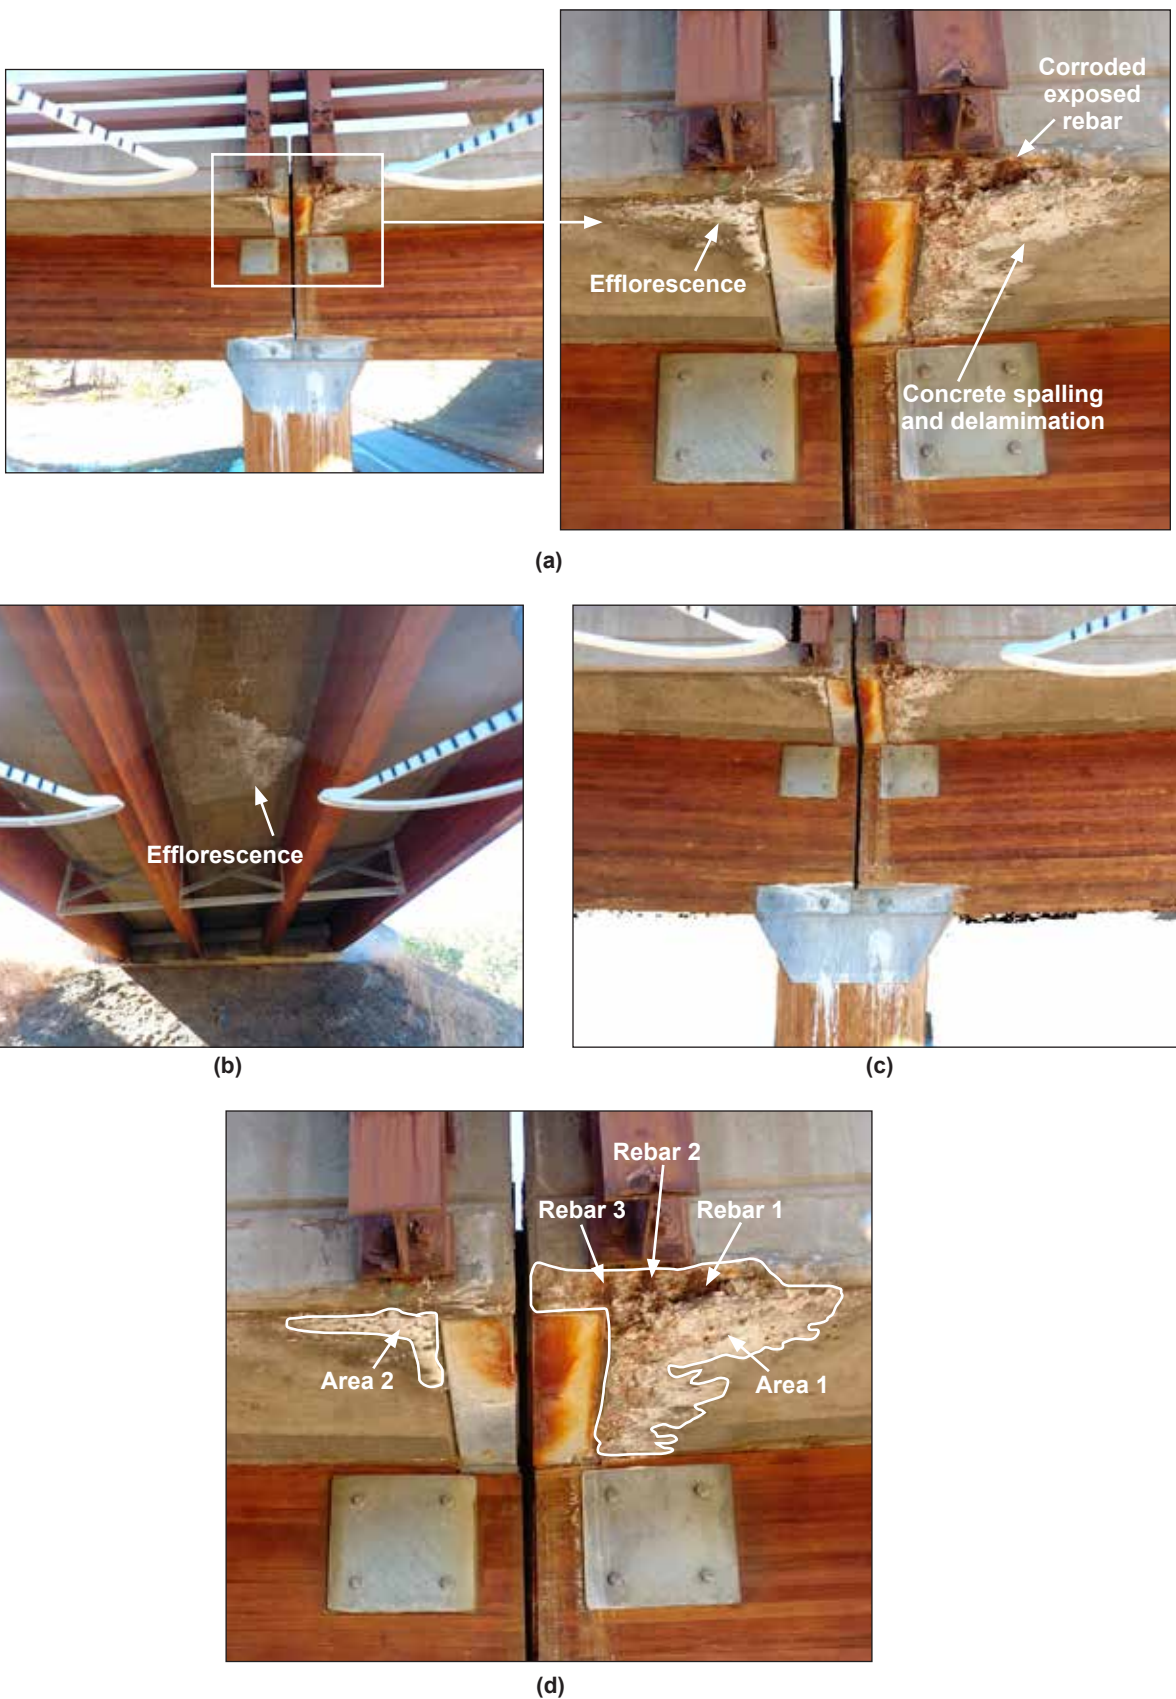
Figure 42. Underside of deck damage detected using drone: (a) concrete spalling and corrosion with exposed rebar at Joint 2 near Girder 4; (b) efflorescence in Bay 2 between Joints 1 and 2; (c) 3D virtual model of Joint 2 near Girder 3 using PhotoScan; (d) quantified damage for Joint 2 near Girder 4.

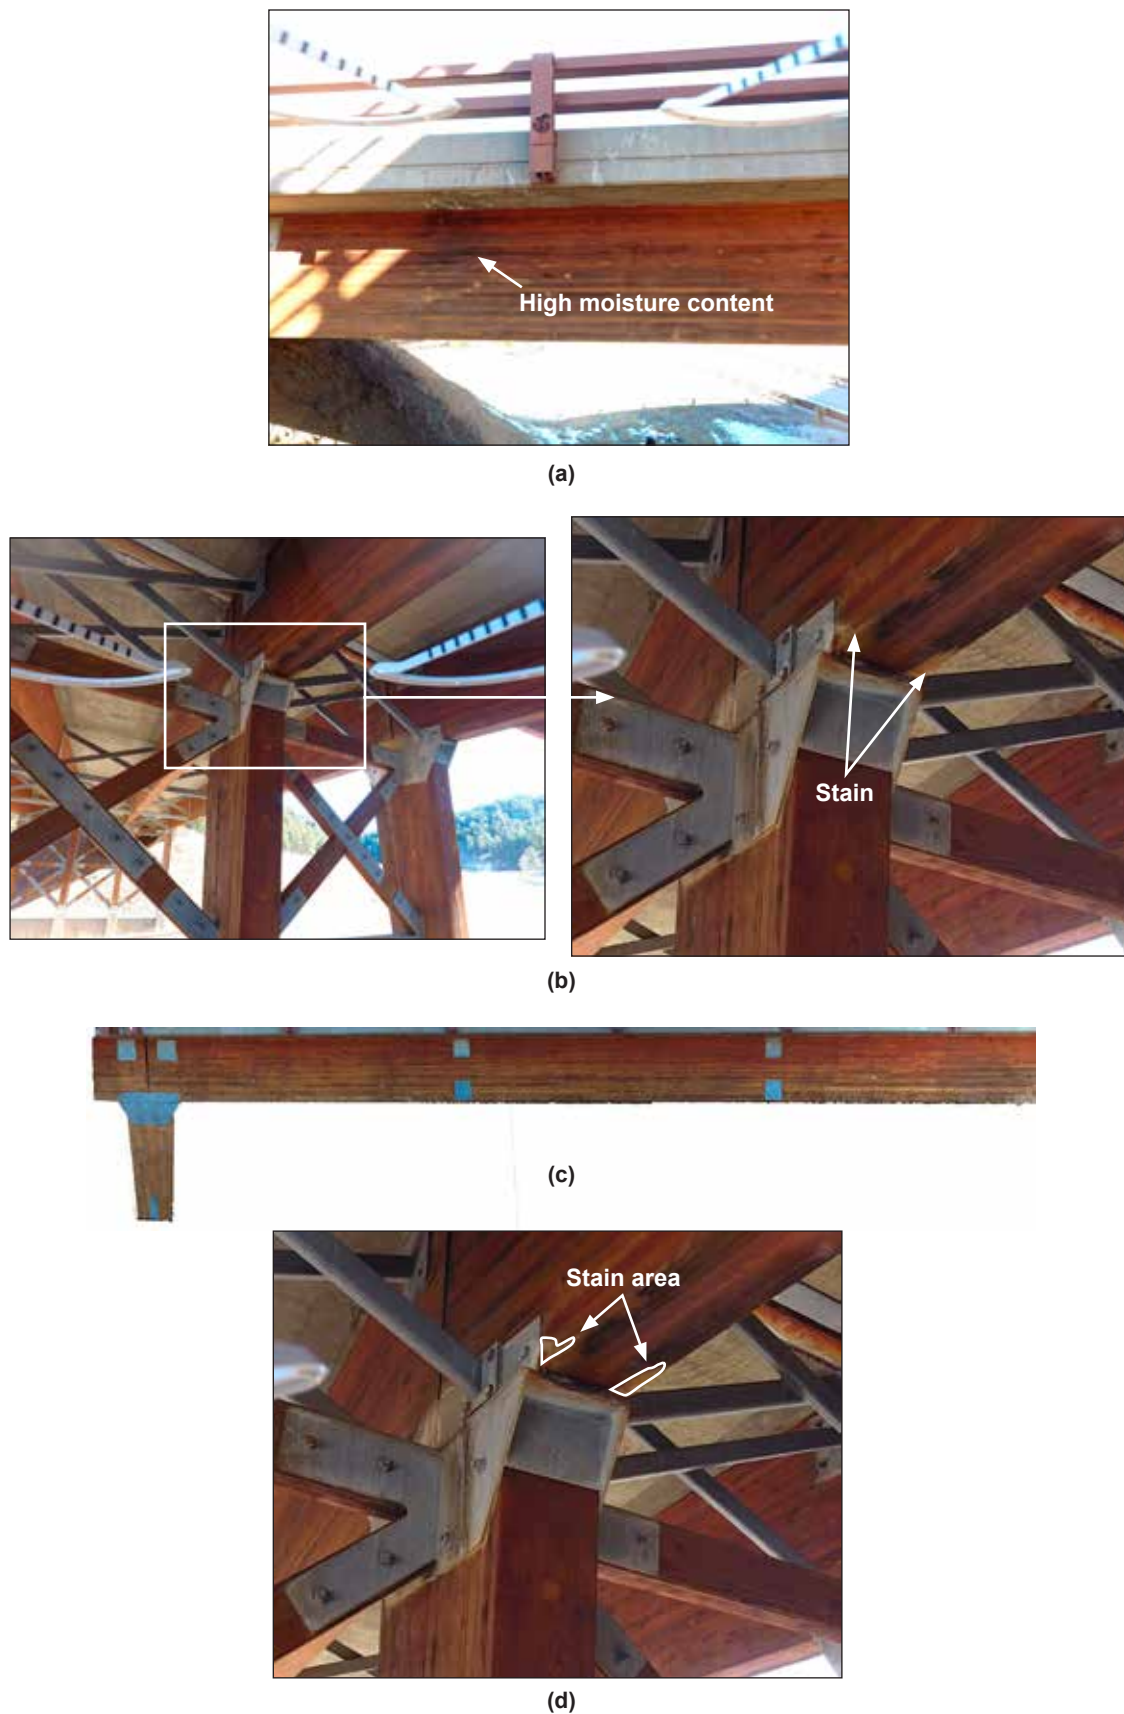
Figure 44. Girder damage detected using the drone: (a) moisture damage on the side of Girder 4 between Joints 1 and 2; (b) stains under Girder 3 at Joint 2; (c) PhotoScan representation of Girder 4 between Joints 3 and 4; (d) damage quantification for Girder 3 support at Joint 2.

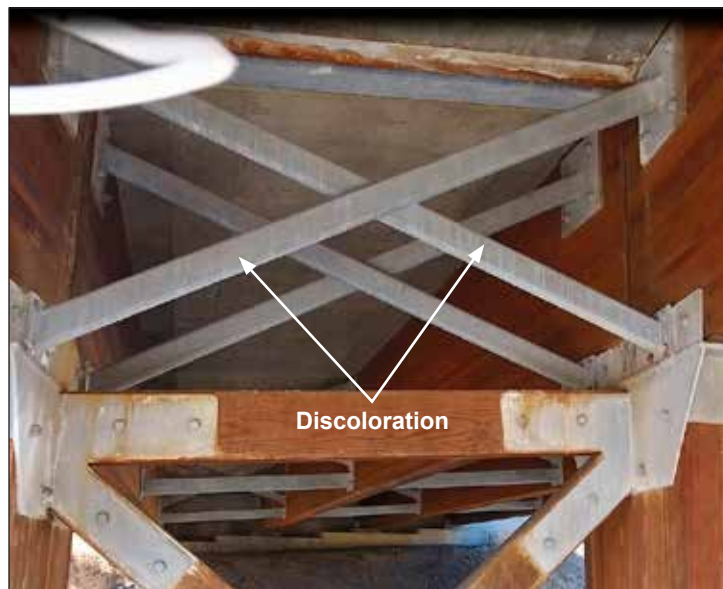
Figure 45. Minor visible discoloration of diaphragms caused by water leakage from the deck at Joint 3.

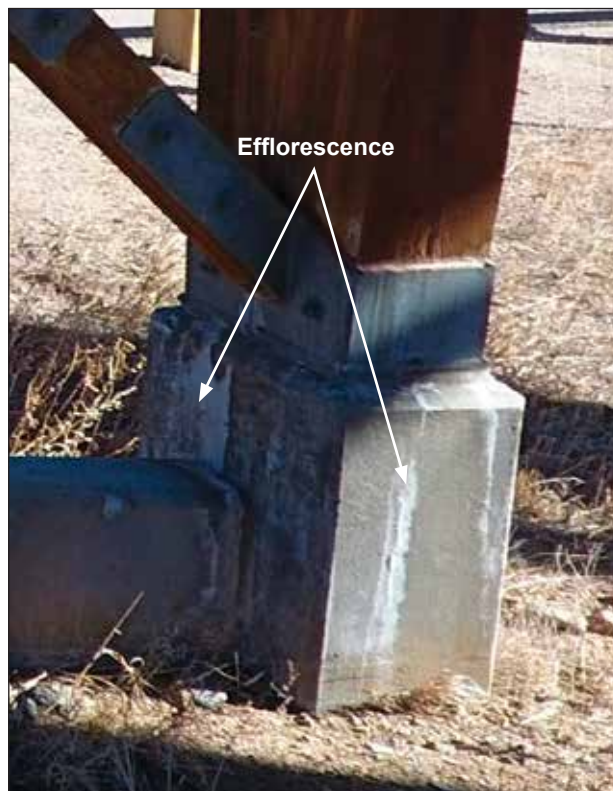
Figure 46. Sample efflorescence on Column 4 Pedestal at Bent 2 detected using the drone.

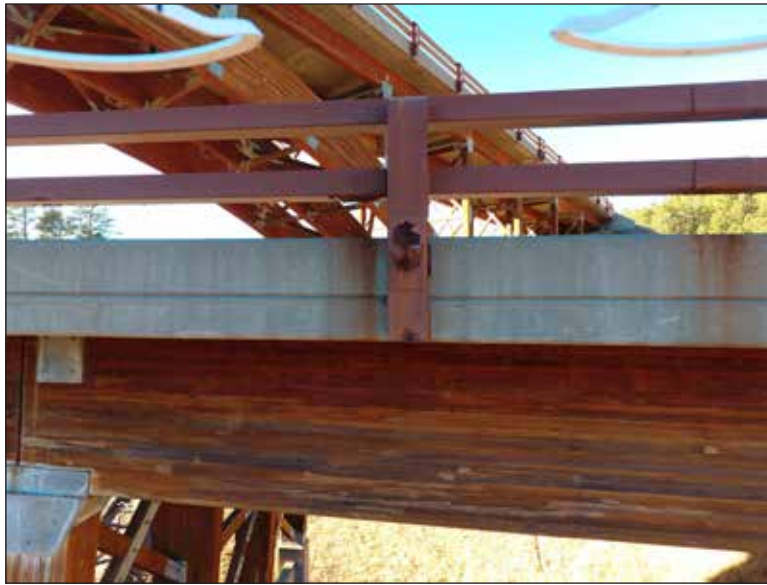
Figure 47. Sample damage on railing between Joints 3 and 4 near Girder 4.

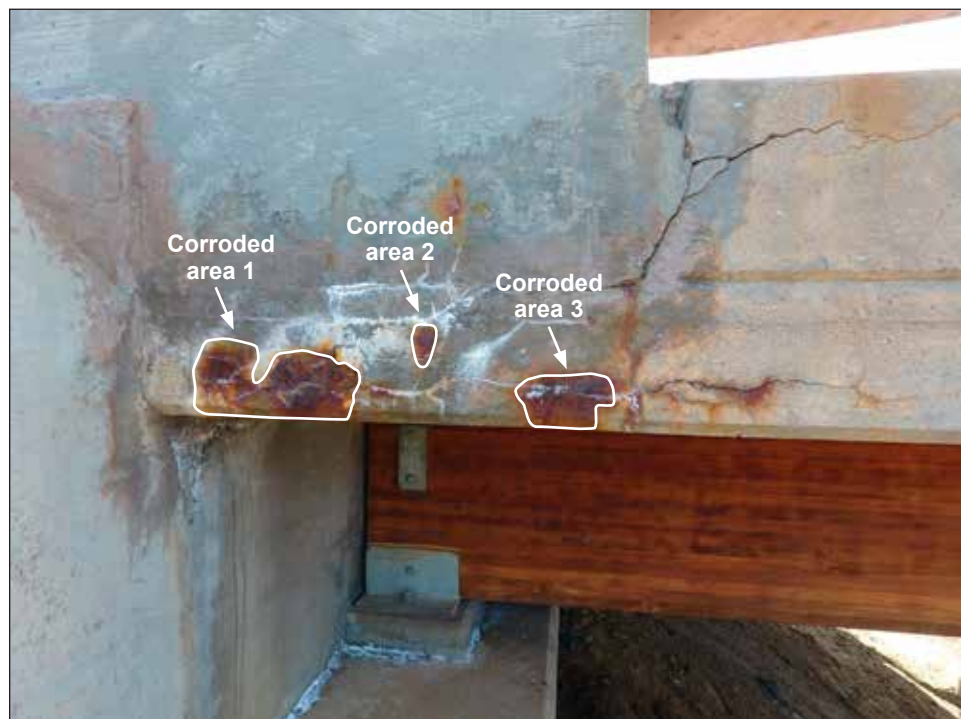
Figure 49. Deck damage identified using drone: (a) concrete cracks, stains, corroded exposed rebar, and moisture of deck near Stringer 1 at Joint 5; (b) concrete spalling and stains at Joint 2; (c) PhotoScan representation of Joint 2 damage; (d) edge detection using ImageJ to better visualize identified cracks and sample crack thicknesses; (e) identified corroded areas.

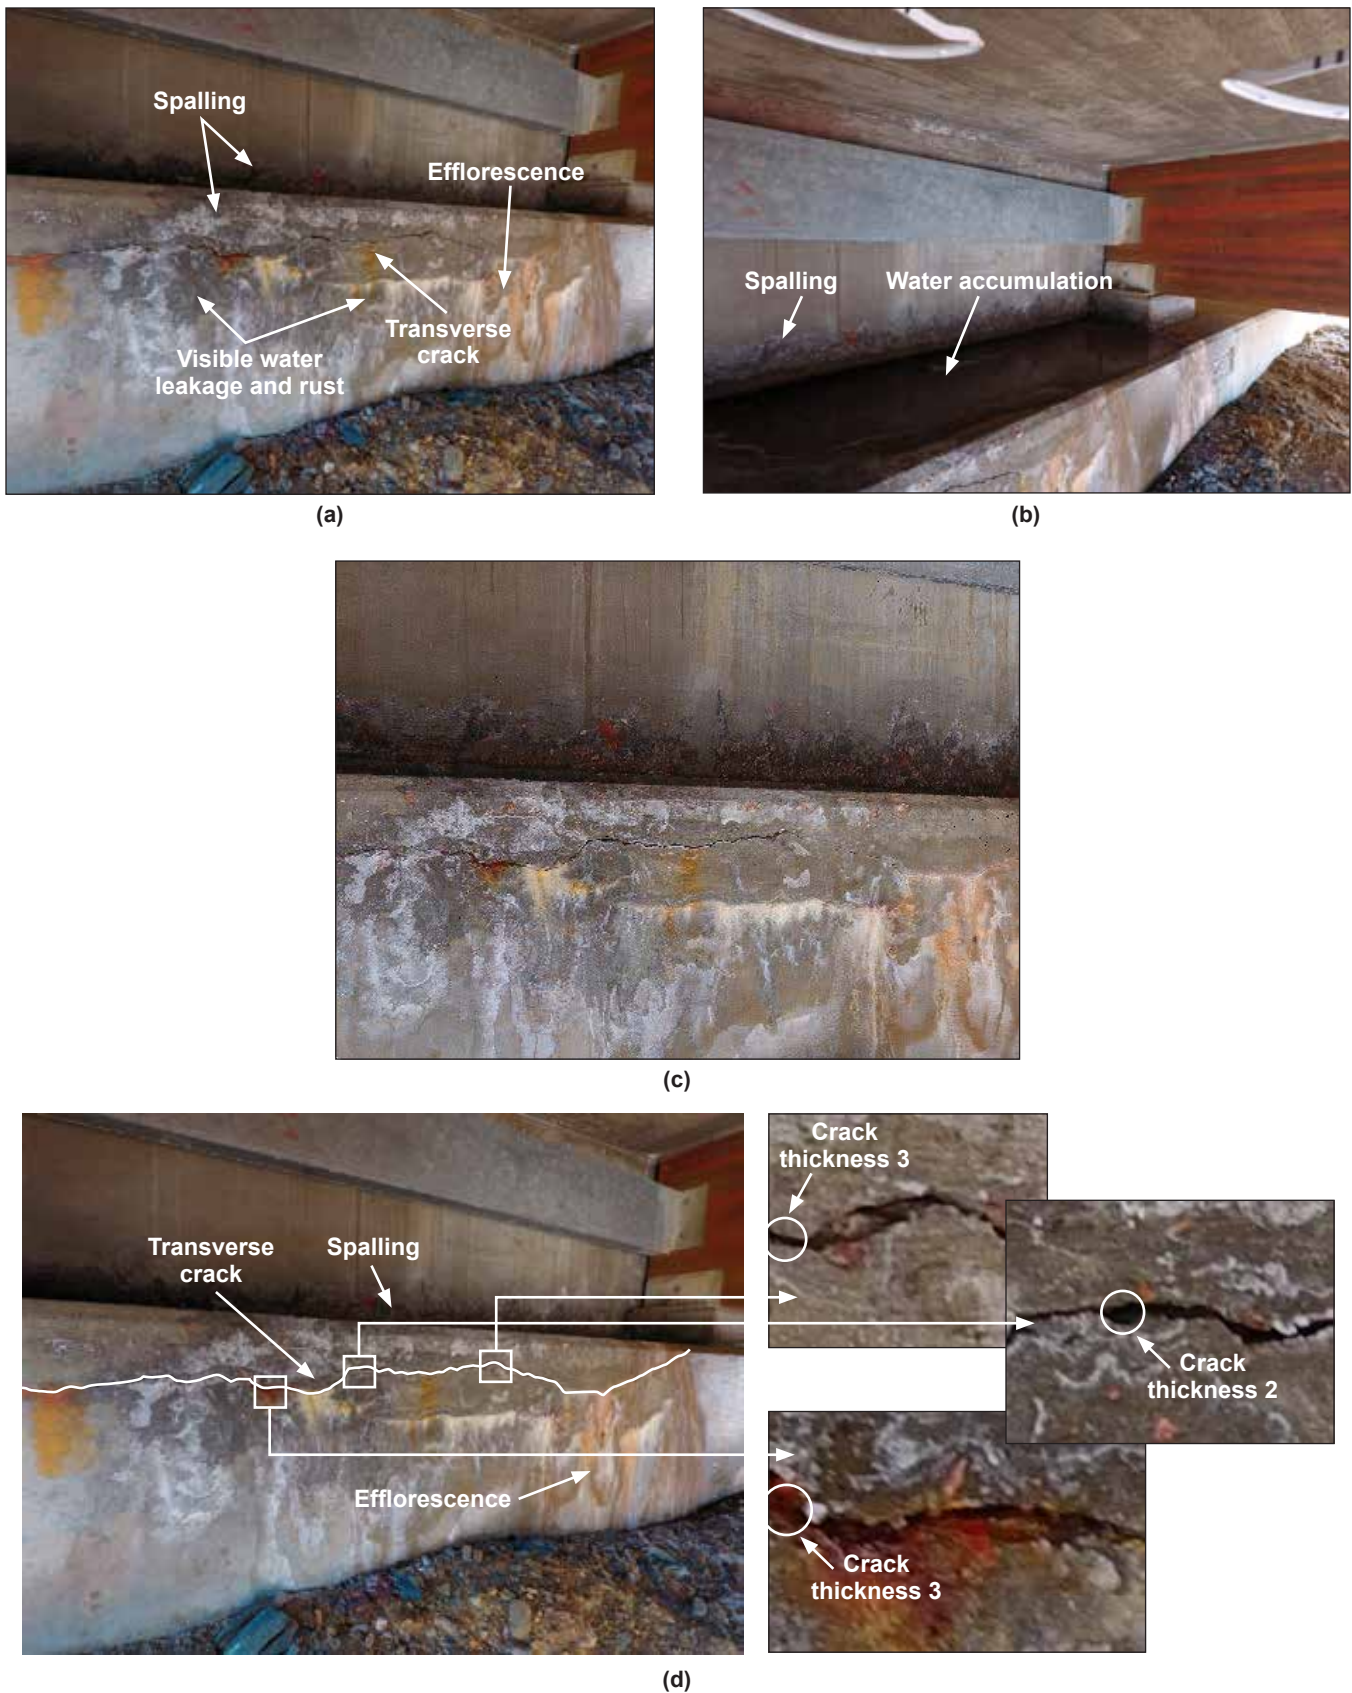
Figure 50. Sample abutment damage detected using drone on Bay 1 at north abutment: (a) transverse concrete crack, visible water leakage, efflorescence, and spalling; (b) water accumulation over crack; (c) PhotoScan 3D virtual representation of north abutment transverse crack; (d) quantified damage on north abutment on Bay 1.

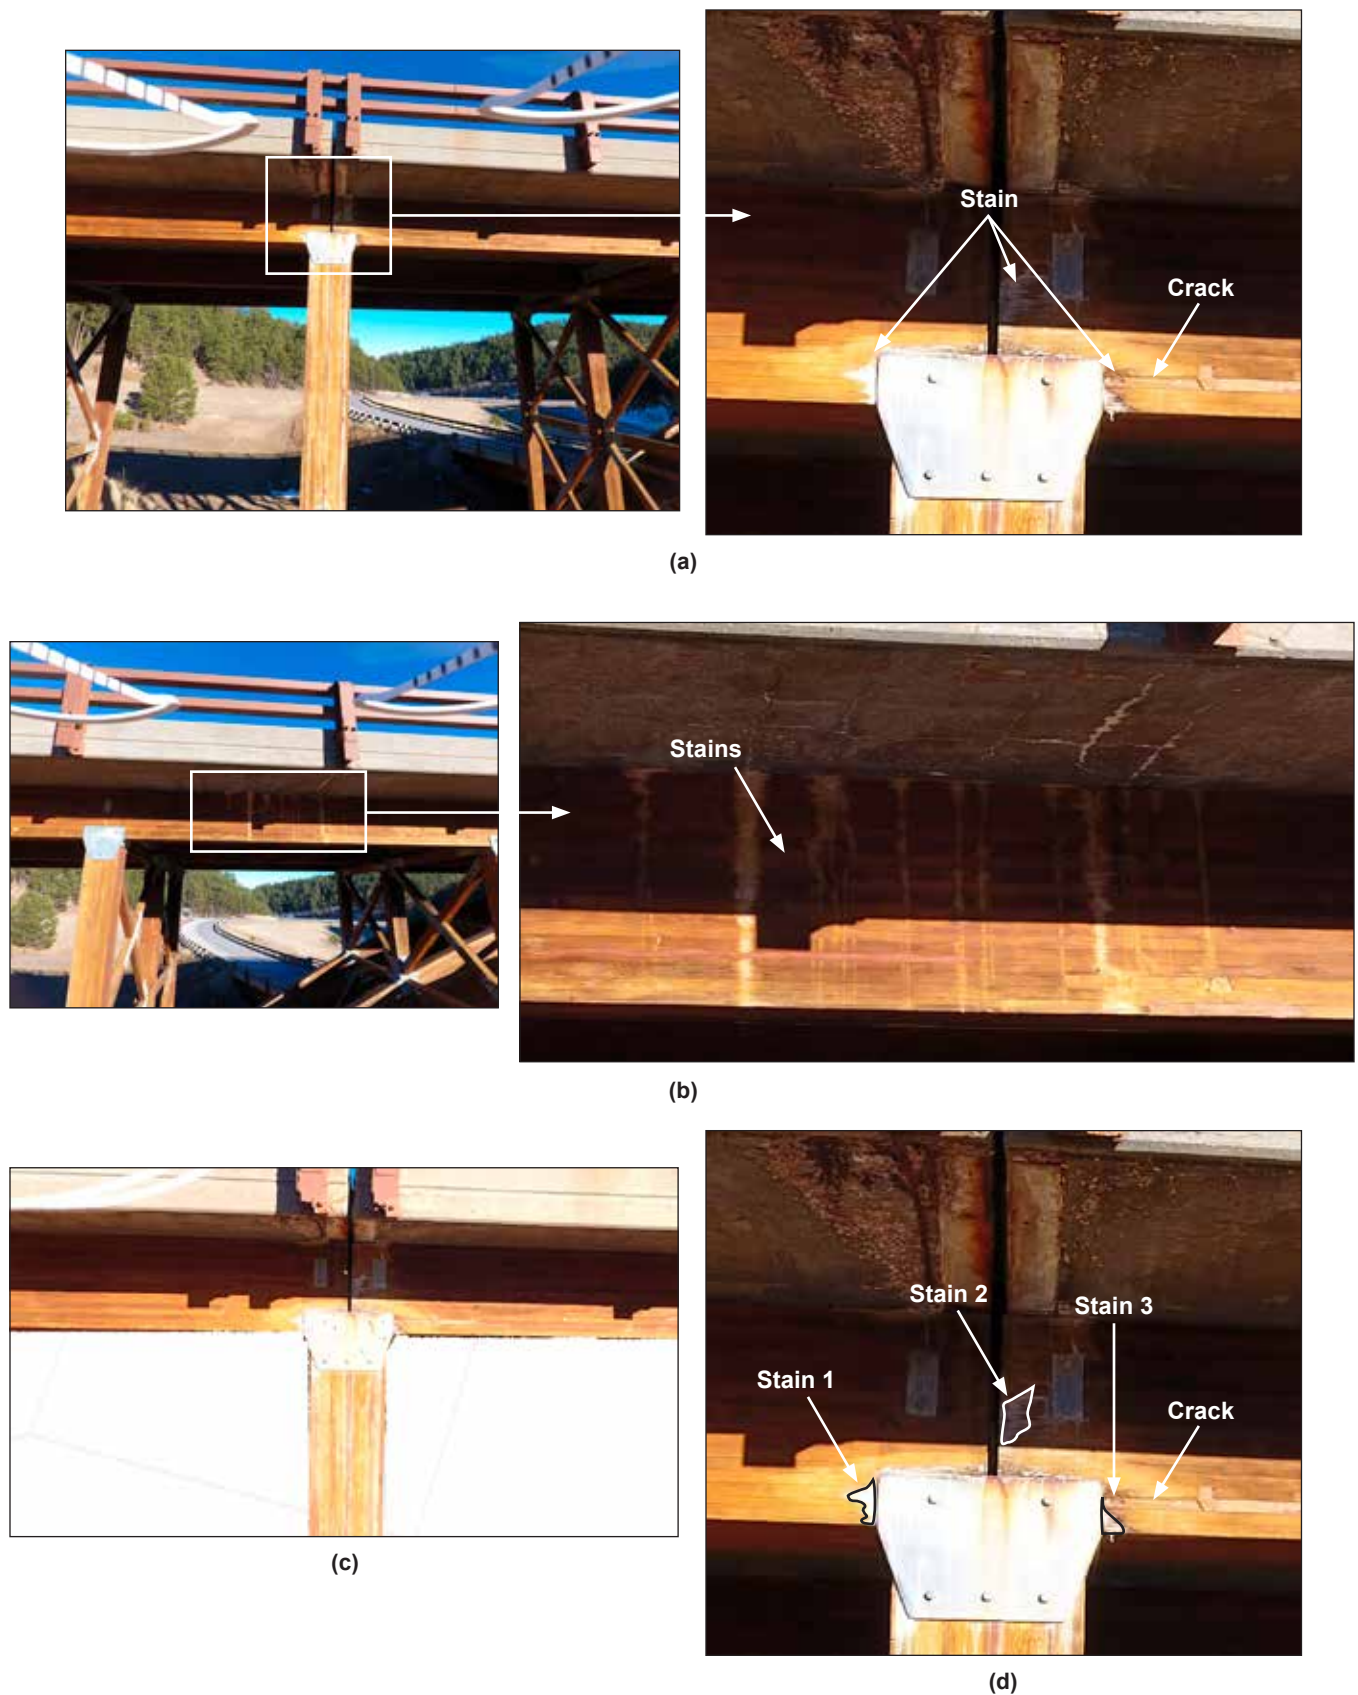
Figure 51. Example stringer damage detected using the drone: (a) discoloration caused by moisture coming from Joint 4 and a shear crack on Stringer 1 at Joint 4; (b) stains caused by water leakage coming from the deck on Stringer 1 between Joints 3 and 4; (c) 3D virtual representation of Stringer 1 at Joint 4 using PhotoScan; (d) quantified damage on Stringer 1 at Joint 4.

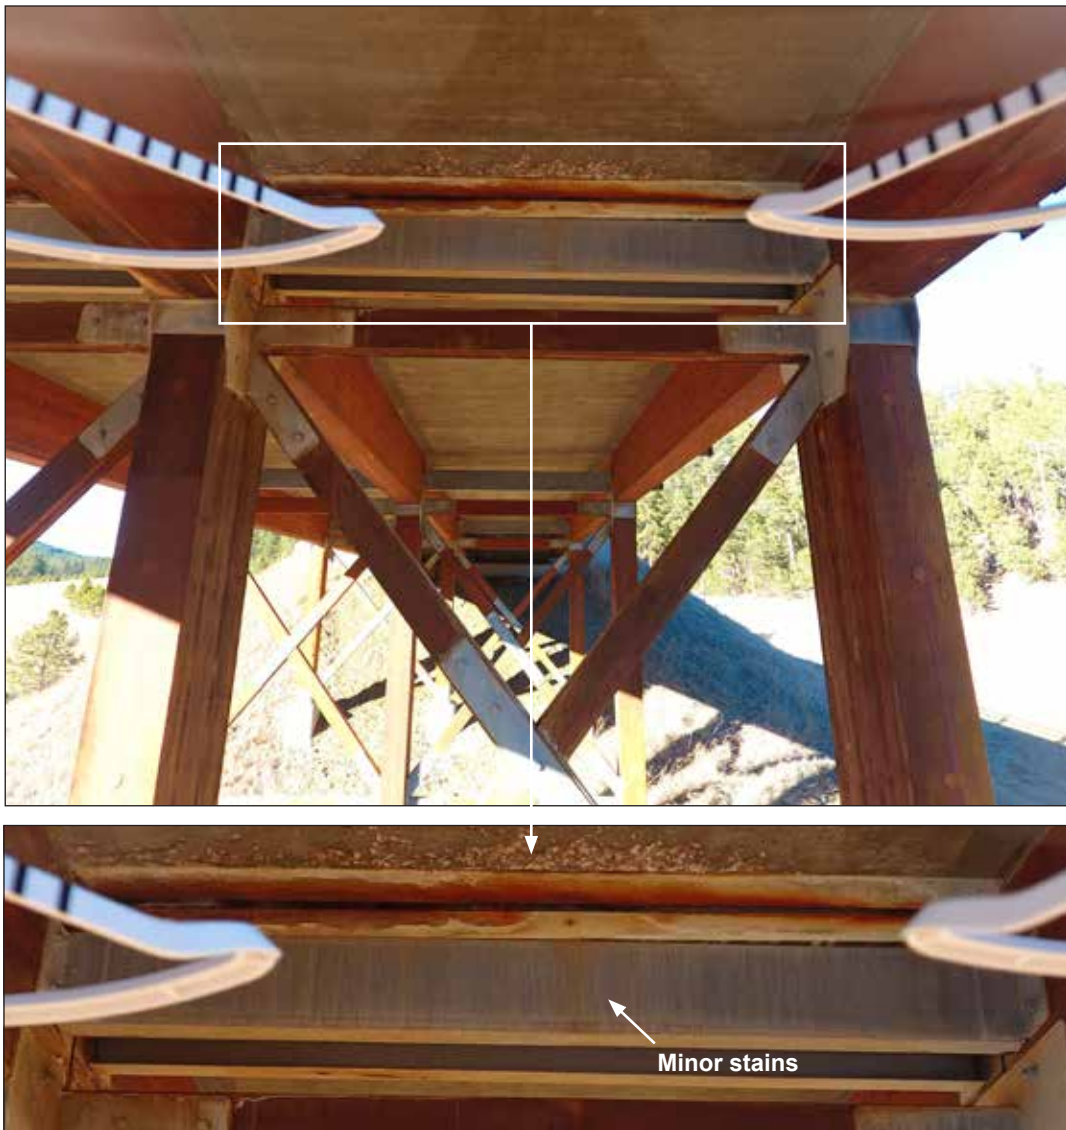
Figure 52. Minor stains on diaphragm on Bay 2 at Joint 4.

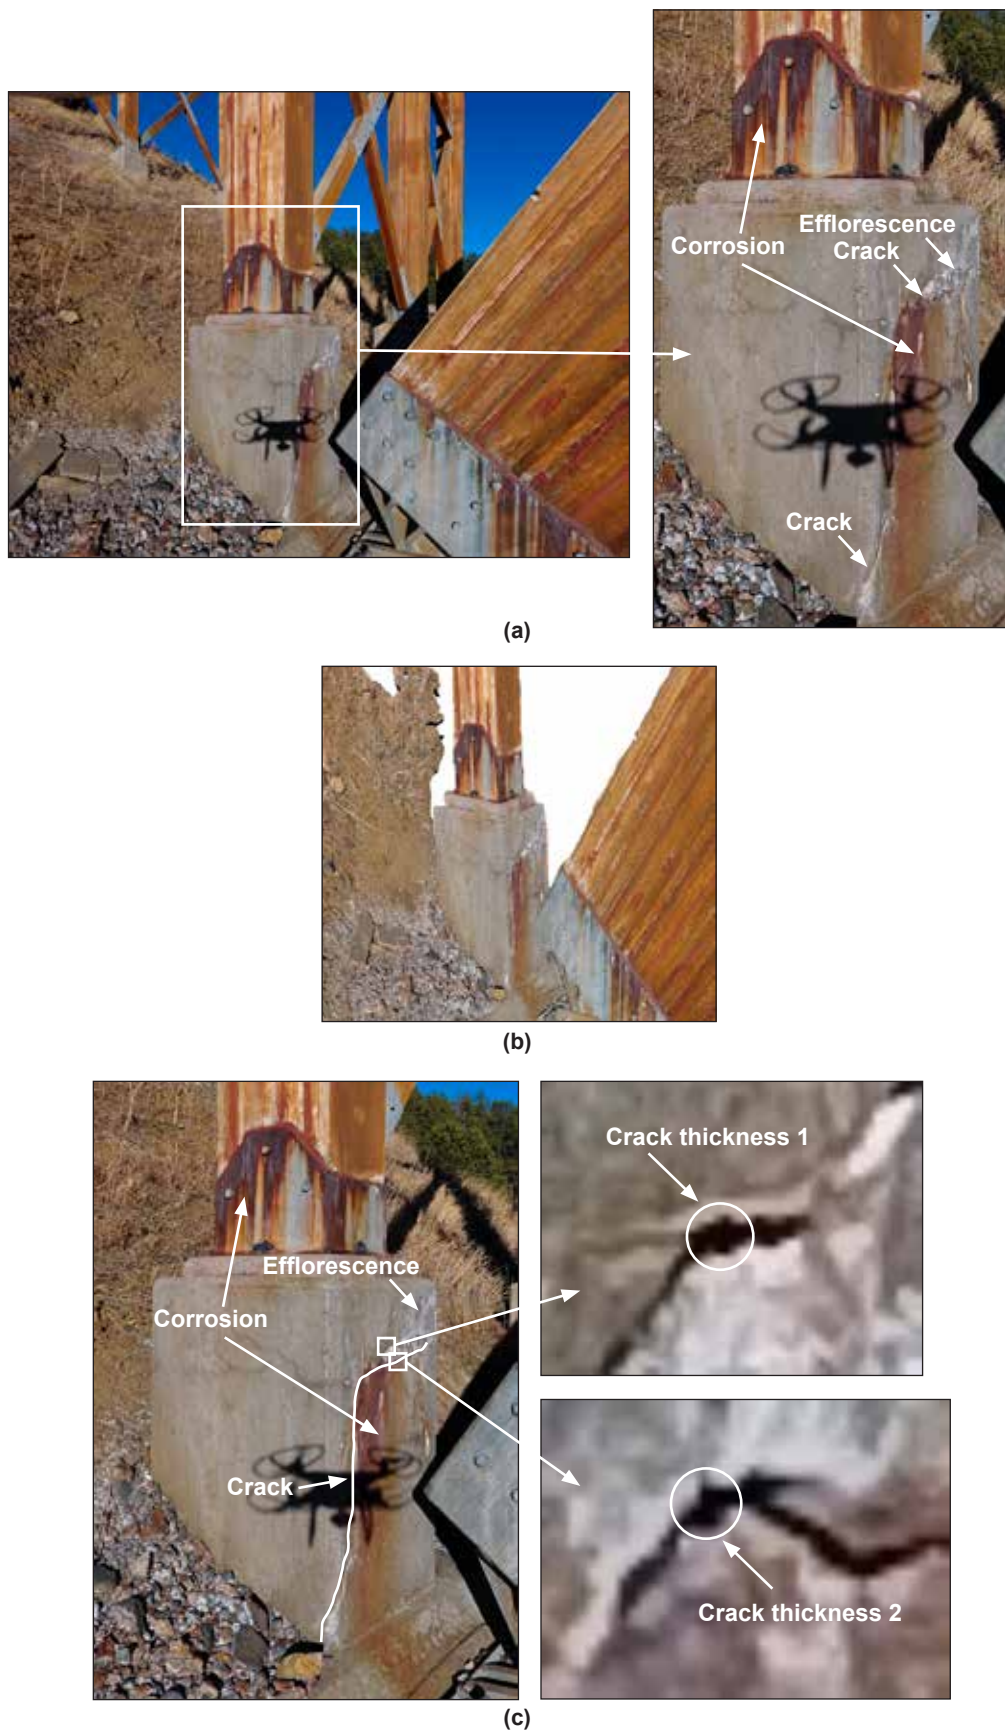
Figure 53. Sample damage on Column 4 at Bent 12 detected using the drone: (a) damage on column; (b) 3D virtual representation of column; (c) detailed column damage for quantification.

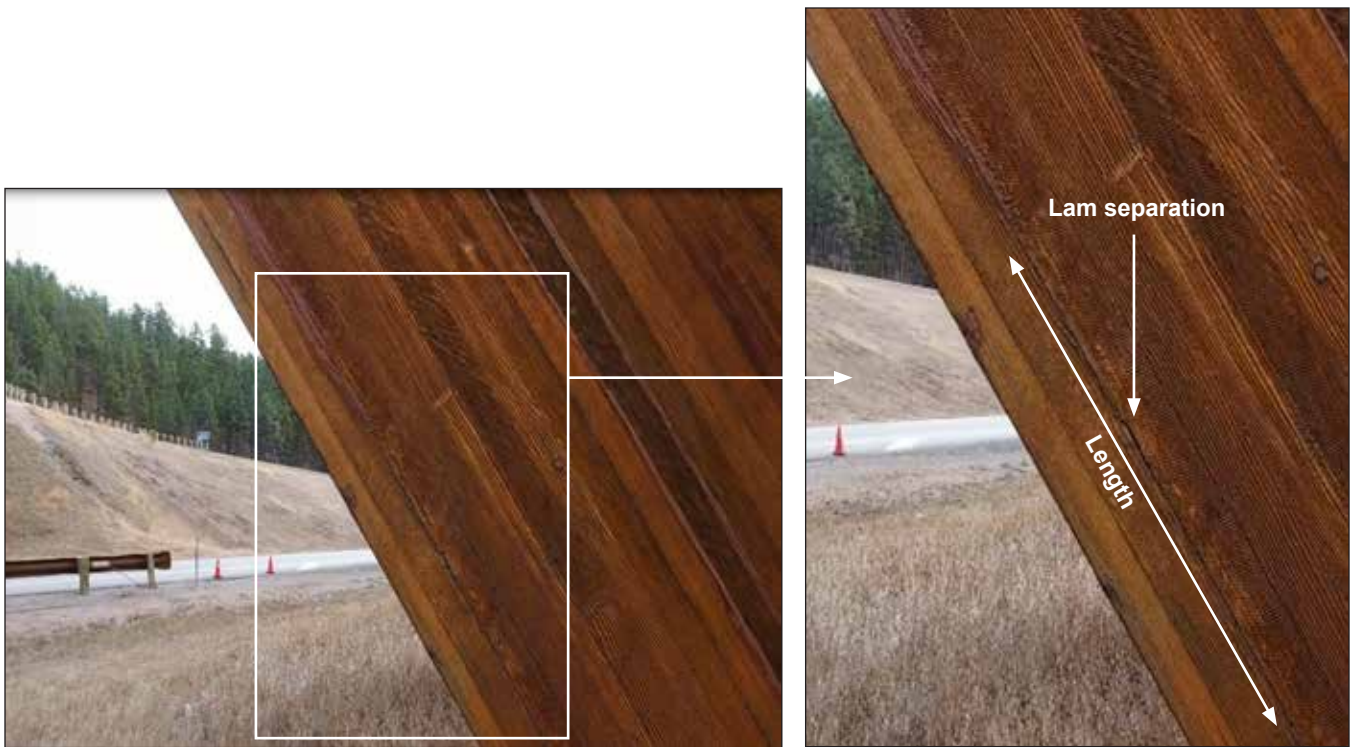
Figure 54. Example arch damage detected using the drone: slight lam separation on Arch 1 between Bents 4 and 5.

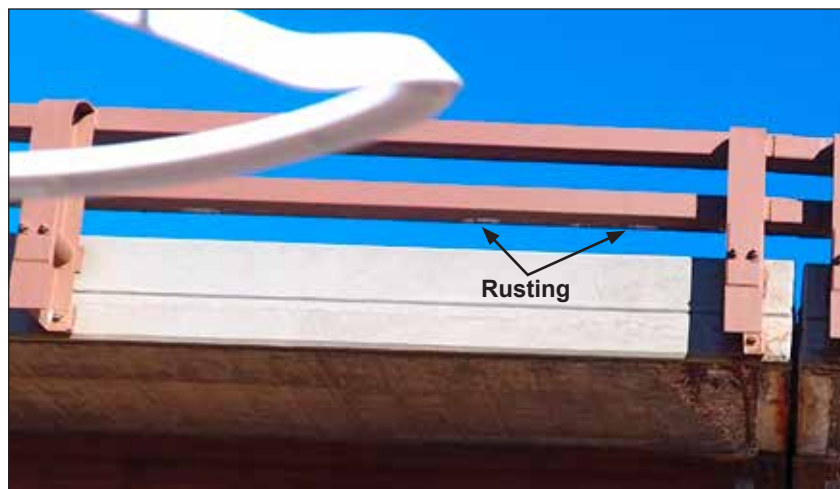
Figure 55. Sample damage on railing near Stringer 1 at Joint 4.

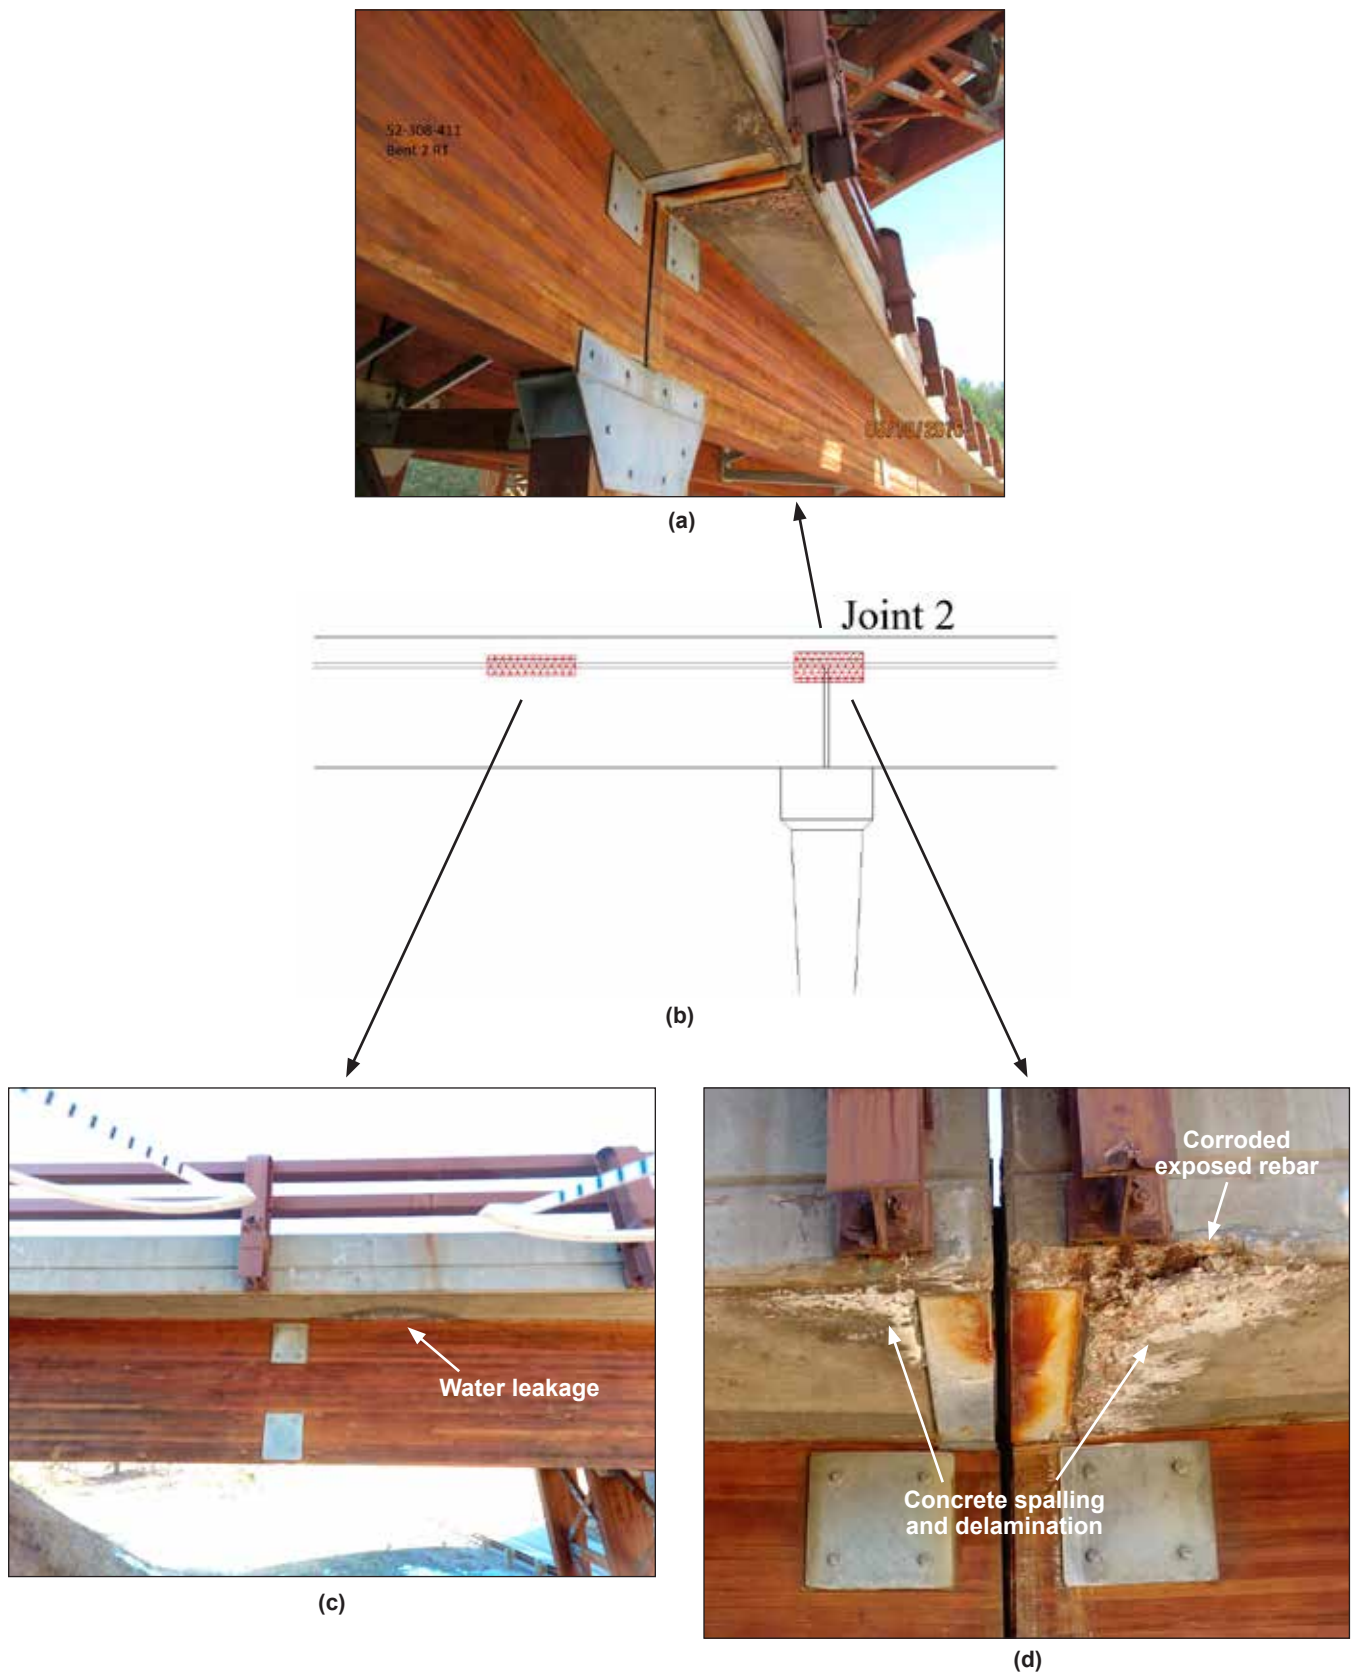
Figure 57. Sample damage on deck near Girder 4: (a) reference image taken during conventional inspection (used with permission from South Dakota Department of Transportation); (b) damage locations on girder; (c) water leakage under deck between Joints 1 and 2; (d) concrete spalling and corrosion with exposed rebar near Girder 4 at Joint 2.

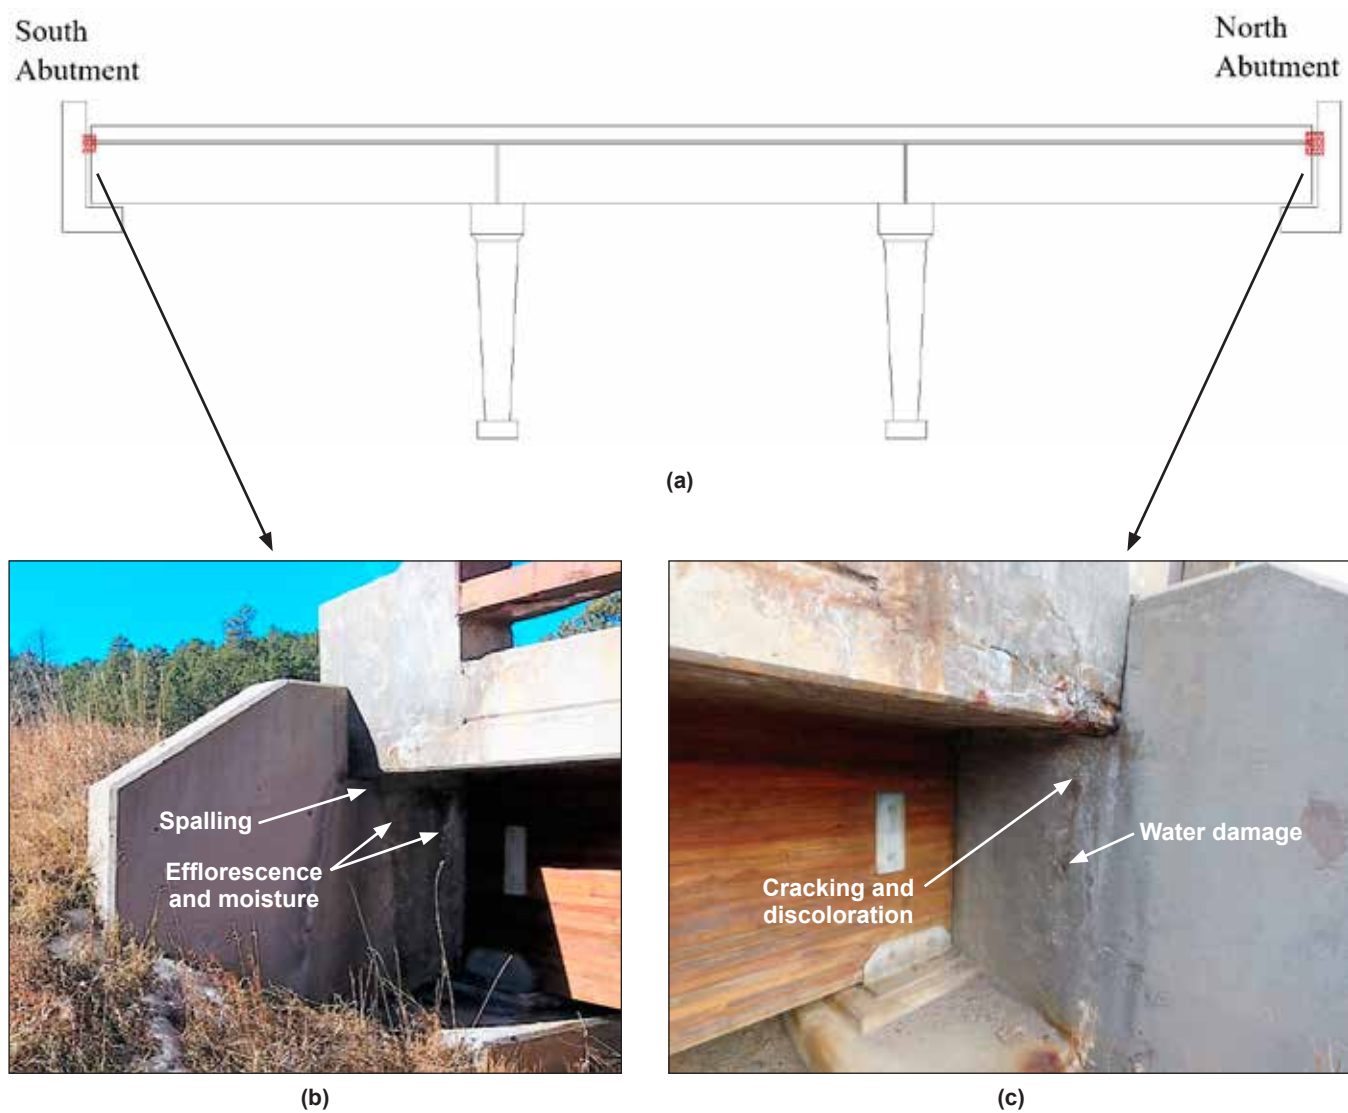
Figure 58. Sample damage on abutment: (a) damage location on abutment; (b) spalling, efflorescence, and moisture on south abutment near Girder 4; (c) cracking, discoloration, and water damage at north abutment near Girder 4.
